Melody™

Transcatheter Pulmonary Valve (TPV) Therapy

Melody TPV therapy is a non-surgical option to restore pulmonary valve function in children and adults with post-operative right ventricular outflow tract (RVOT) conduit or surgical bioprosthetic pulmonary valve dysfunction.

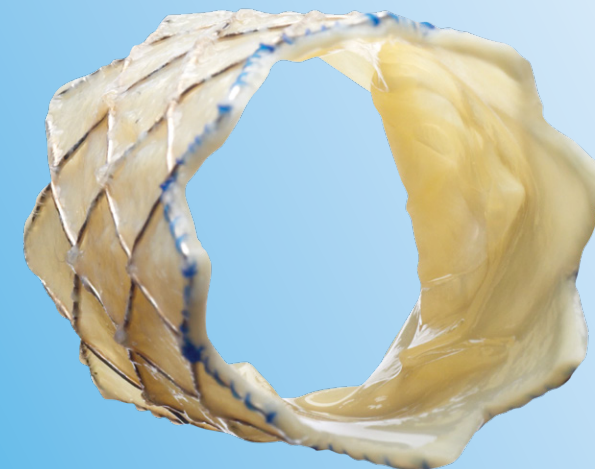
EXCEPTIONAL DELIVERABILITY AND EASE OF USE

The Ensemble™ II Transcatheter Delivery System is designed for controlled, stepwise deployment of the valve with balloon-in-balloon technology.

- Simple hand crimping and loading
- Balloon marker bands aid in visualization of valve position on the balloons prior to unsheathing and during deployment
- Integrated sheath eliminates need for additional sheath and protects valve during delivery
- Flexible 16 Fr shaft with true 22 Fr outer diameter profile

- Balloon-in-balloon catheter delivery system with a retractable polytetrafluoroethylene (PTFE) sheath covering.
- Nylon inner and outer balloons available in three sizes: 18 mm, 20 mm, and 22 mm. At inflation, the inner balloon is half the diameter of the outer balloon.
- Sheath with side port for flushing the system and a hemostatic sleeve to minimize bleeding at the insertion site.

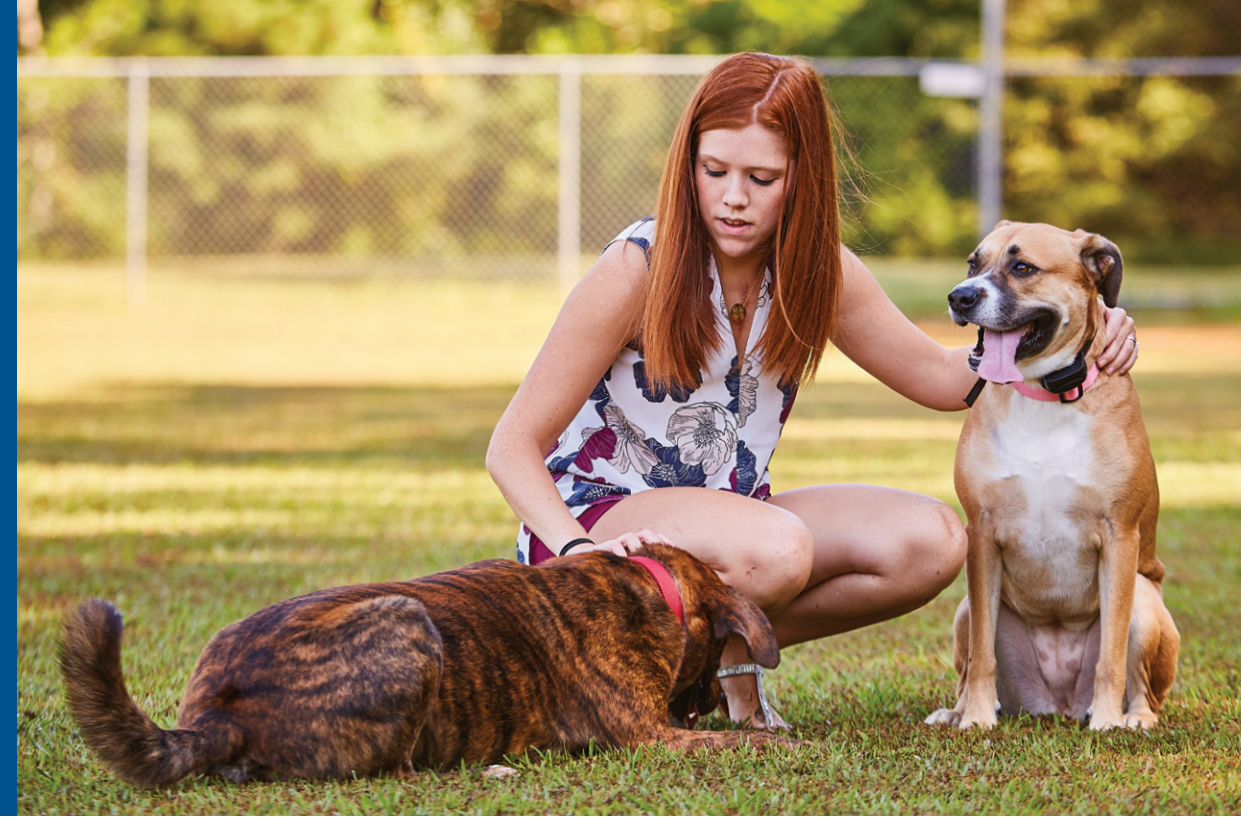
DELAYS PATIENT'S NEXT SURGICAL INTERVENTION

Low rates of surgical conduit reoperation out to 8 years.

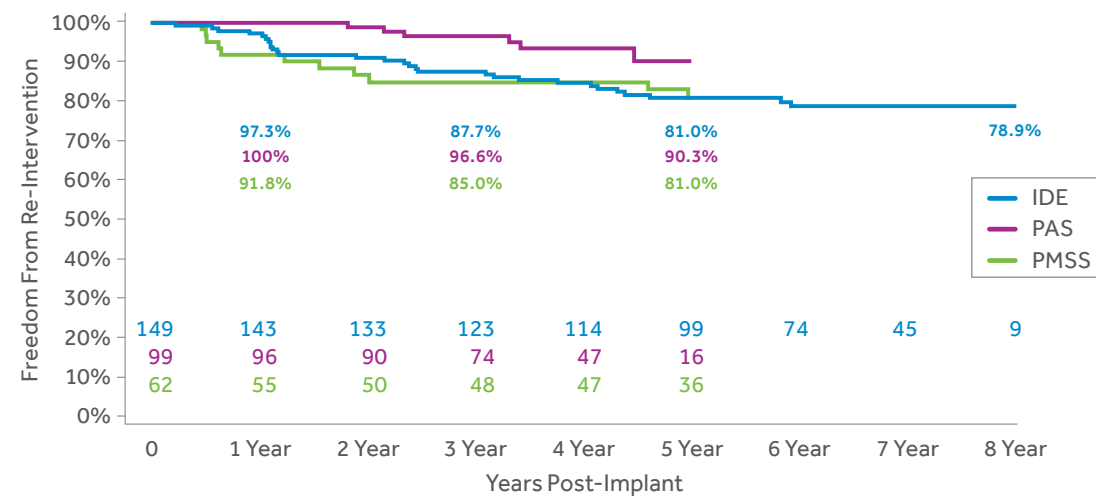
FREEDOM FROM CATHETER RE-INTERVENTION

Freedom from catheter-based re-intervention on the TPV was greater than 78% out to 8 years.

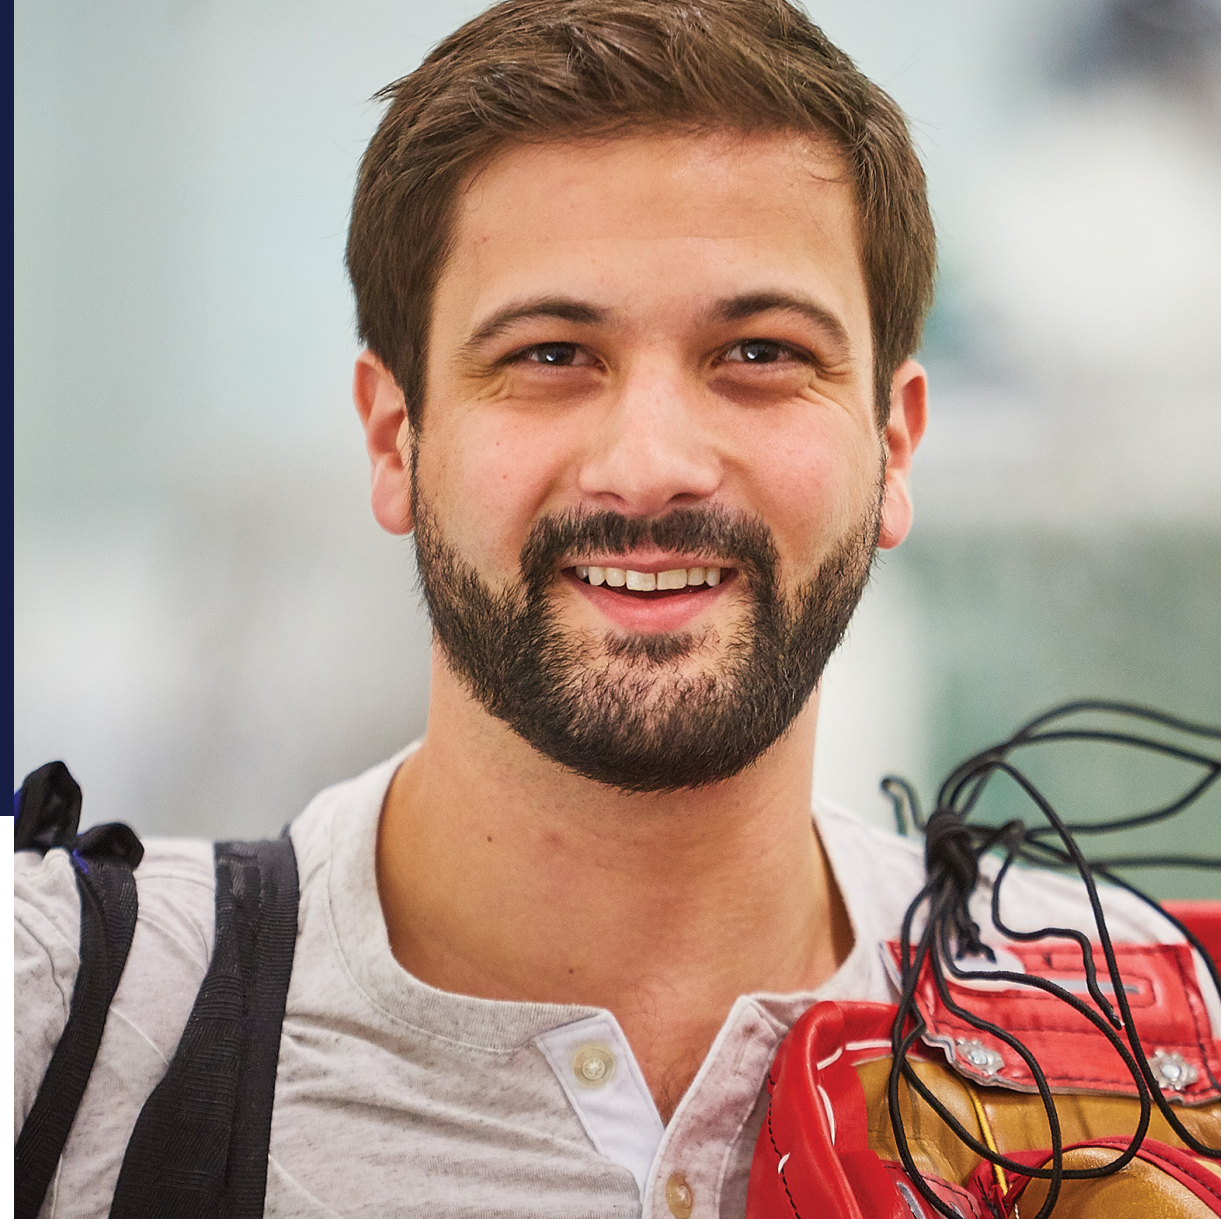
IMPROVES FUNCTIONAL STATUS

At baseline, the majority of subjects in all 3 studies were in NYHA class II/III. Following Melody TPV implant, the majority of subjects were in NYHA class I, which remained consistent during follow-up.
